# Property Inspection Report

**Report Number: NC22012**

1391 Plaza West Road  
Somewhere, North Carolina 12345

Date of Inspection: Tuesday, June 14, 2022

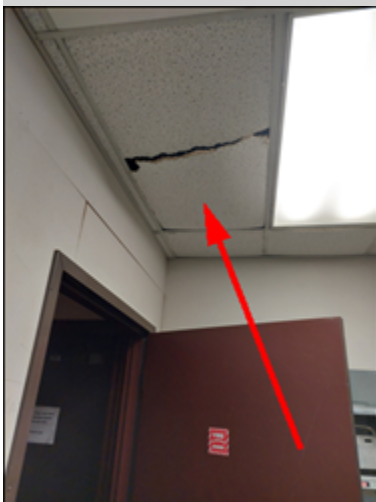
**(A5 - 1.2 ) All Accessible Interior Areas**

The ceiling tiles in several rooms are cracked, broken or chipped. No related concerns were noted in the throughout the other inspection areas. The buyer should review the area of concern. If additional concerns or questions are present, invasive inspection and repair will be needed.

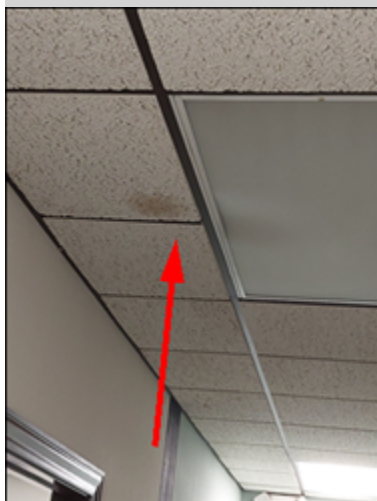
**(A5 - 1.7 ) All Accessible Interior Areas**

From the attic, the wood framing components located in an interior room are discolored. The framing, insulation, and ceiling show evidence of a history of a leak. A licensed general contractor should be consulted for further evaluation and repair to determine the source of the leak and extent of the damage to ensure the stability of the home and prevent additional damage.

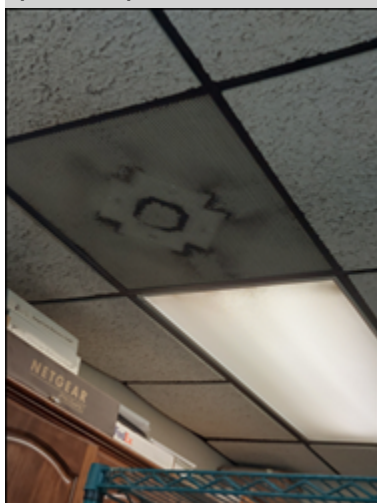
**(A5 - 1.8 ) All Accessible Interior Areas**

Ceiling diffuser for HVAC show signs of previous moisture in system. There is no obvious dripping at time of inspection. Further evaluation is recommended by qualified HVAC contractor to review.

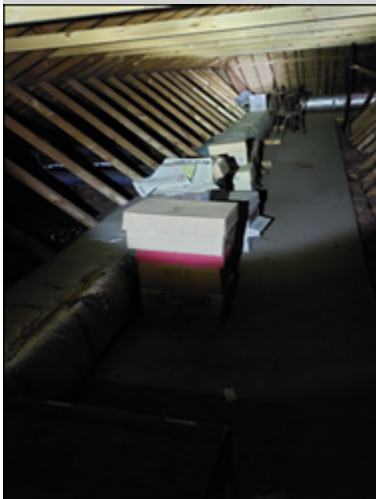
**(A6 - 1.1 ) Main Building**

There is a considerable amount of stored Boxes and furniture that should be removed. Further investigation is needed.

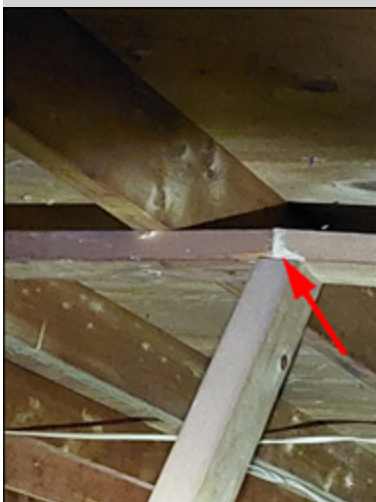
**(A6 - 1.2 ) Main Building**

From the attic, the roof rafters were noted to be bowed or warped beyond what would be typically expected. The bowing could indicate an underlying problem with the rafter design, installation, or attic conditions. An engineer should be consulted for further evaluation to determine the significance of the concern and outline necessary repairs to ensure the stability of the structure.

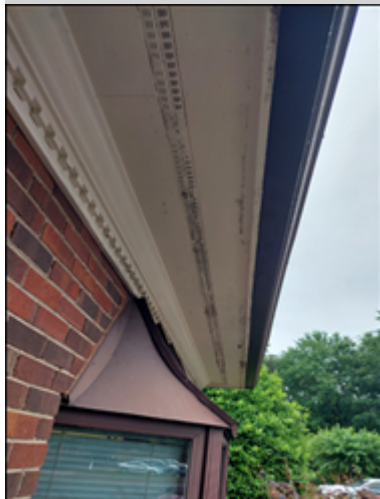
**(B1 - 1.1 ) Main Building**

The fascia and soffits need attention as paint is peeling and there is some areas of decay. The boxing and trim areas were found to have areas of damage/decay related to problems with the gutters and roof drainage. Water is flowing behind gutter trays and leaking from the gutter seams. Repairs are needed to the boxing and gutter system. A licensed general contractor should be consulted for a complete evaluation of the exterior of the building to determine the extent of the damage to the boxing, trim, and underlying components to ensure the weathertightness of the system.

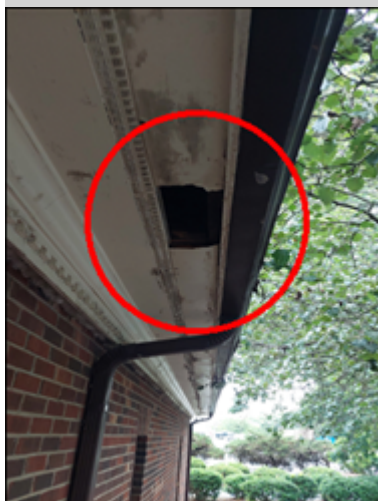
**(B1 - 1.4 ) Main Building**

The fascia and soffits need attention as paint is peeling and there is some areas of decay. The boxing and trim areas were found to have areas of damage/decay related to problems with the gutters and roof drainage. Water is flowing behind gutter trays and leaking from the gutter seams. Repairs are needed to the boxing and gutter system. A licensed general contractor should be consulted for a complete evaluation of the exterior of the building to determine the extent of the damage to the boxing, trim, and underlying components to ensure the weathertightness of the system.

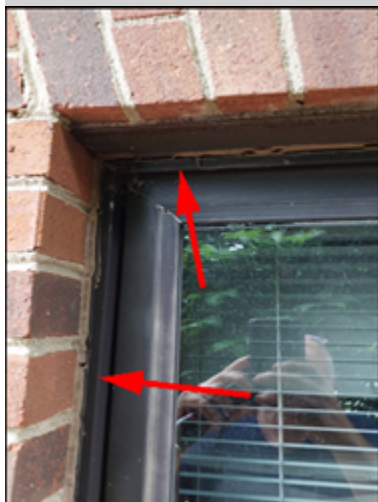
**(B2 - 1.1 ) Window**

All windows in building need to be caulked and sealed to avoid water penetration. Water penetration will lead to rot and mold. A licensed general contractor should be consulted to determine the extent of the damage and make necessary repairs.

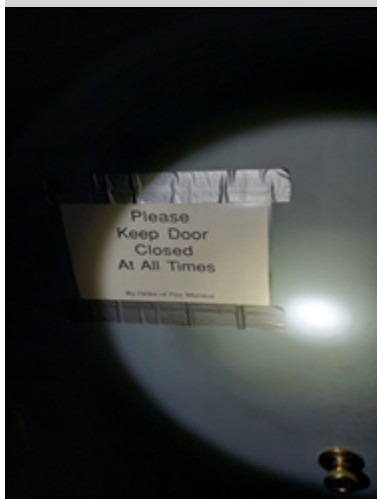
### (B2 - 1.5 ) Window

The fire doors in the attic that separate the gas furnaces DO NOT have strike plates. Therefore, the fire doors are not operating as intended. This is a safety fire hazard. A General Contractor should be consulted for further review.

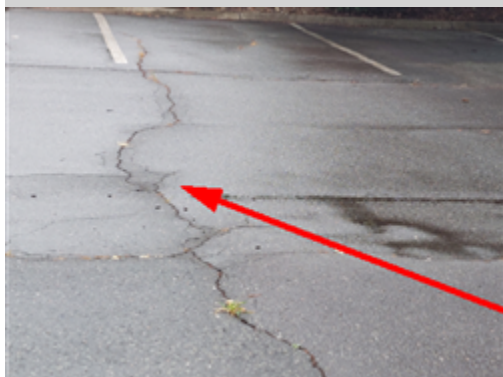
#### (B4 - 1.1 ) Driveway

The driveway is cracked and displaced. The raised section of the driveway has created a path for water penetration under the slab and a trip or fall hazard. A licensed general contractor should be consulted for further evaluation and repair.

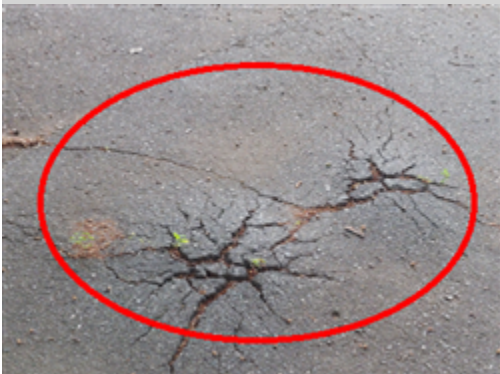
**(B4 - 1.4 ) Driveway**

The driveway is cracked and displaced. The raised section of the driveway has created a path for water penetration under the slab and a trip or fall hazard.

There is noticeable damage to the driveway due tree roots growing beneath in a number of locations. We recommend a licensed general contractor with landscaping experience and grading should be consulted for further evaluation and repair.

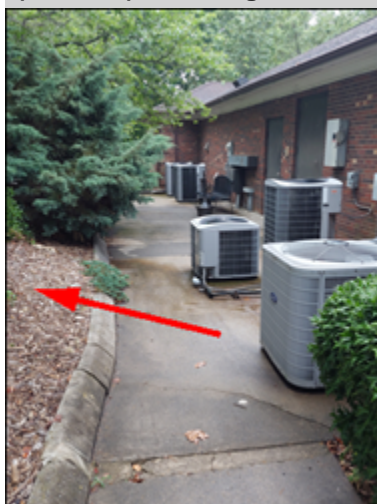
**(B5 - 1.1 ) Grading**

The grading around the package HVAC unit is directing drainage toward the unit and into the building. Direct water penetration into the slab is undesirable and should be corrected. A licensed general contractor should be consulted to make necessary repair to ensure correct lot drainage and that the foundation area will be dry and stable.

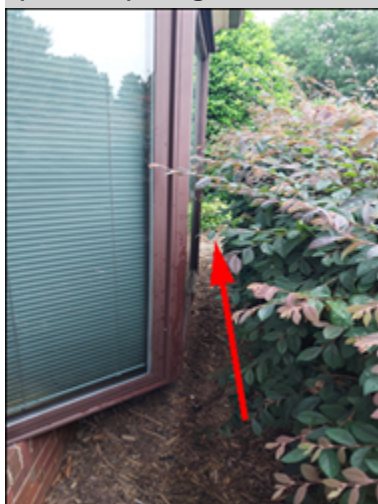
#### (B5 - 2.1 ) Vegetation

The vegetation around the perimeter of the building is over grown and blocks the air circulation around the building. The growth also limited the inspection access. A landscaping company should be consulted to correct the over growth and the inspection should be completed prior to purchase.

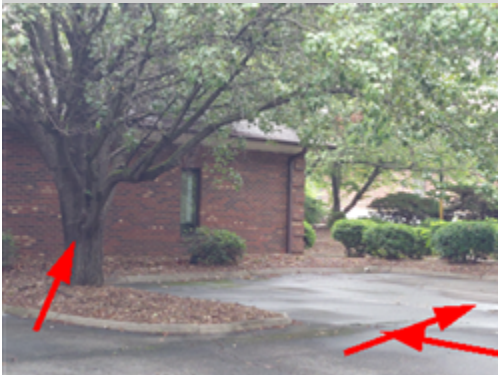
**(B5 - 2.4 ) Vegetation**

This building has a large tree on the right side of the building. This tree could present a sizable hazard to this building if it dies or falls. An arborist should be consulted to determine the general health of the tree, required service, and recommend a care plan. The tree has already caused damage to the driveway as noted previously.

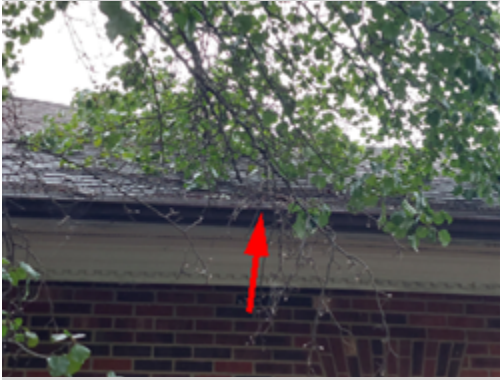
#### (B5 - 2.5 ) Vegetation

The vegetation/tree limbs around the perimeter of the building is over grown and blocks the air circulation around the building including the roof. The growth also limited the inspection access. A landscaping company should be consulted to correct the over growth and the inspection should be completed prior to purchase.

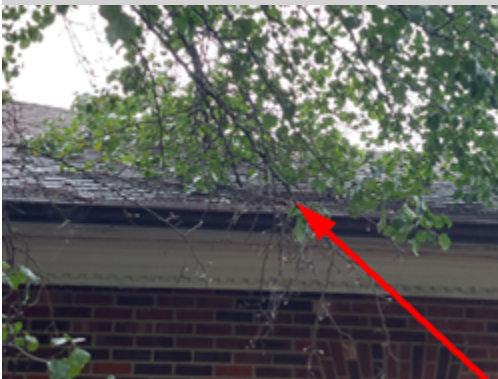
### **(C1 - 1.2 ) Main Building**

The shingles for the building are covered with a heavy build-up of leaves/pine needles/debris. This limited the inspection of the roof surface. Debris on the roof surface can trap moisture allowing water and debris to travel under the shingle tabs resulting in material failure and leaks. A roofing contractor should be consulted to remove the debris and inspect the shingles/adjacent component for evidence of damage and make necessary repairs.

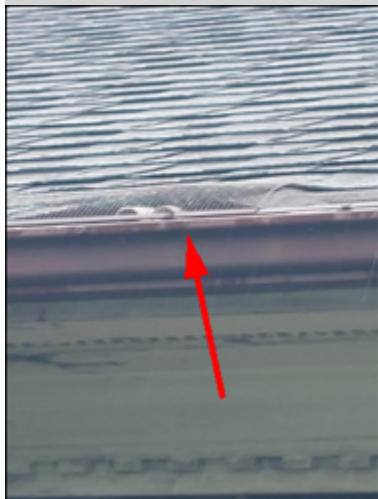
**(C1 - 1.4 ) Main Building**

An installed condensate drain has shingles bunched up on eave. Further investigation is recommended by a licensed contractor.

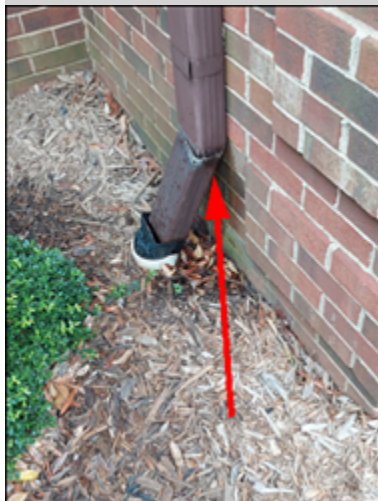
**(C2 - 1.1 ) Main Building**

There are several gutter downspout that are damaged and working improperly. Direct drainage to the foundation and cladding from the gutter system can result in water penetration into the foundation area and foundation deterioration. A licensed general contractor should be consulted for a complete evaluation and to make necessary repairs.

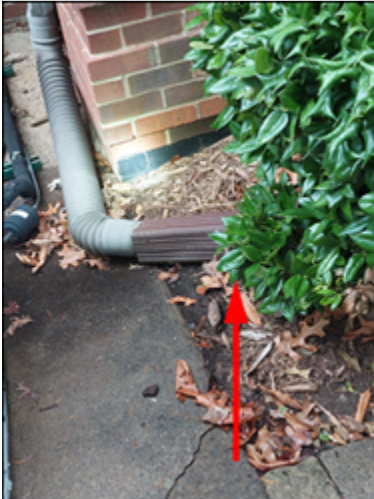
**(C2 - 1.2 ) Main Building**

The gutter downspouts are not extended or piped correctly to direct roof drainage away from the foundation. Direct drainage to the foundation and cladding from the gutter system can result in water penetration into the foundation area and foundation deterioration. A licensed general contractor should be consulted for a complete evaluation and to make necessary repairs.

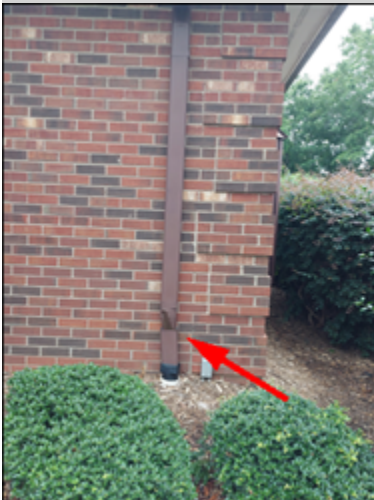
**(C2 - 1.4 ) Main Building**

There are several gutter downspout that are damaged and working improperly. Direct drainage to the foundation and cladding from the gutter system can result in water penetration into the foundation area and foundation deterioration. A licensed general contractor should be consulted for a complete evaluation and to make necessary repairs.

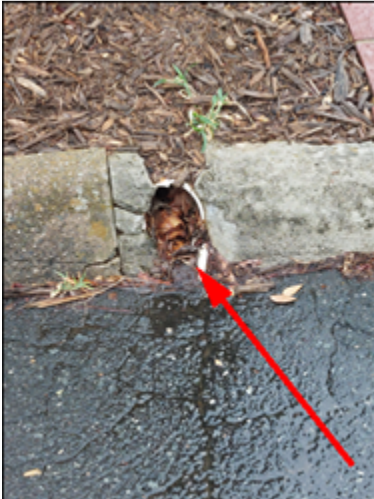
**(C2 - 1.5 ) Main Building**

Drain is clogged with leaves and debris. A licensed general contractor should be consulted for a complete evaluation and to make necessary repairs.

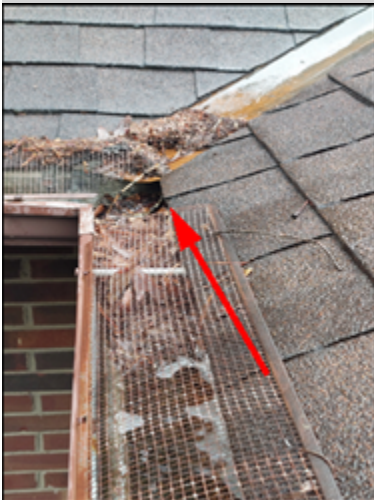
**(C2 - 1.6 ) Main Building**

Evidence of debris in the valley impeding gutters from working properly. Direct drainage to the foundation and cladding from the gutter system can result in water penetration into the foundation area and foundation deterioration. A licensed general contractor should be consulted for a complete evaluation of the gutter system to reduce overflow and to make necessary repairs.

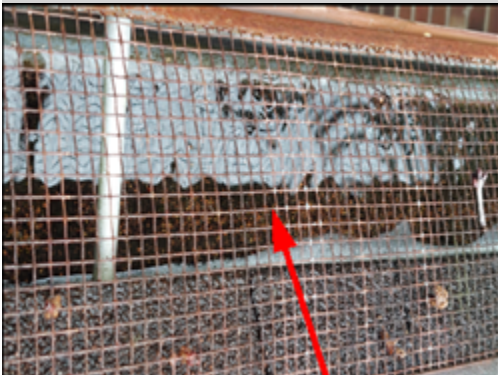
**(C2 - 1.7 ) Main Building**

Standing water was noted in the gutter trays in several locations. This indicates that the gutters are not draining and could indicate improper tray slope, a clogged exits, or downspout extension. Direct drainage to the foundation and cladding from the gutter system can result in water penetration into the foundation area and foundation deterioration. A licensed general contractor should be consulted for a complete evaluation of the gutter system to reduce overflow and to make necessary repairs.

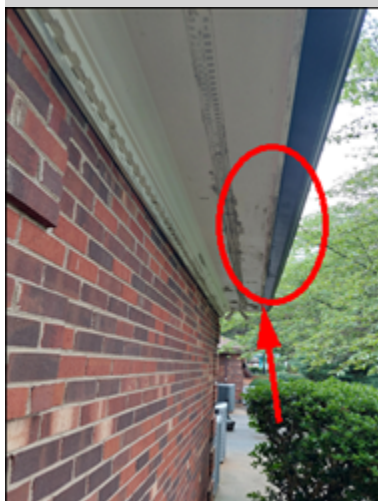
**(C2 - 1.8 ) Main Building**

The gutter trays have been leaking at seams and corners. It is very important to keep gutter functioning properly to reduce direct drainage to the foundation and wall cladding systems. A licensed general contractor should be consulted a complete evaluation and to make necessary repairs.

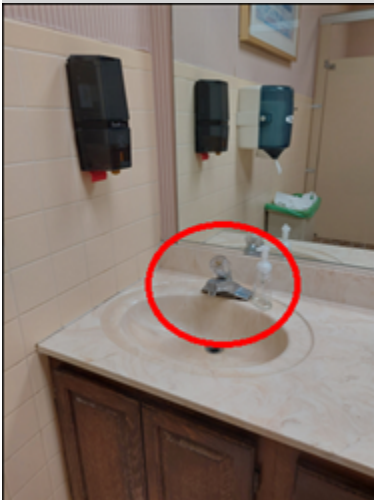
**(D2 - 2.4 ) Bathroom**

The faucet in the women's bathroom is not connected properly and loose. This could leak to leaking water pipes. A qualified technician should be consulted for further evaluation.

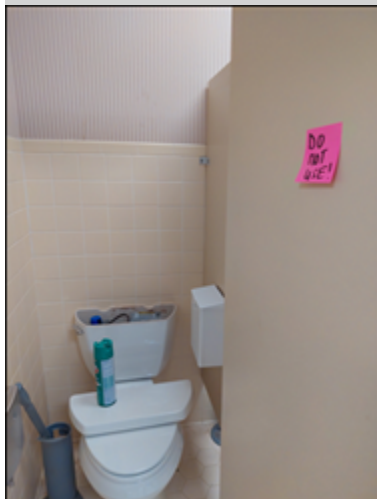
**(D2 - 2.5 ) Bathroom**

The toilet in the women's bathroom is not functioning properly. This could leak to leaking water pipes. A qualified technician should be consulted for further evaluation.

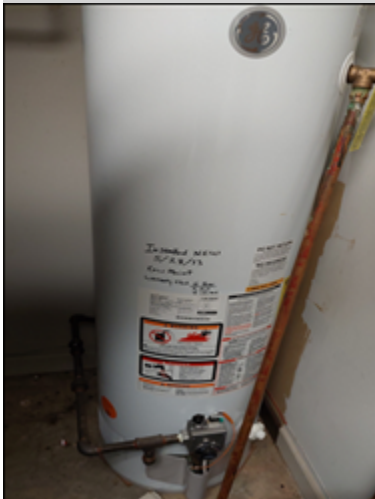
**(D3 - 1.2 ) Unit #1**

The water heating unit for this building is 9 years old. A water heating unit has a life expectancy of 10 to 12 years. The unit was noted to be operational and fair condition. The unit should be serviced annually and the TPRV inspected and or replaced every three years. The buyer should budget for replacement.

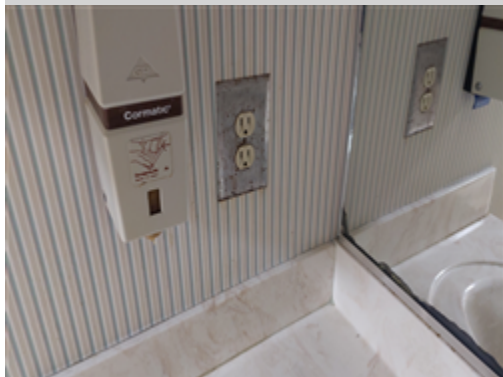
**(E5 - 1.1 ) Bathroom**

The building was built before GFCI circuits were required to protect all electrical receptacles located outside or within six feet of water. GFCI circuits add an important safety feature to electrical systems. The buyer should consider upgrading the electrical system to include GFCI protection.

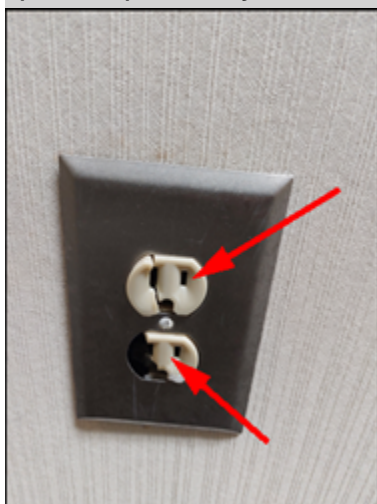
**(E5 - 2.1 ) Hallway**

The receptacle(s) has/have cracked face. A cracked receptacle could result in increased shock and fire hazards. A licensed electrical contractor should be consulted to make necessary repairs to ensure safe and proper operation and installation.

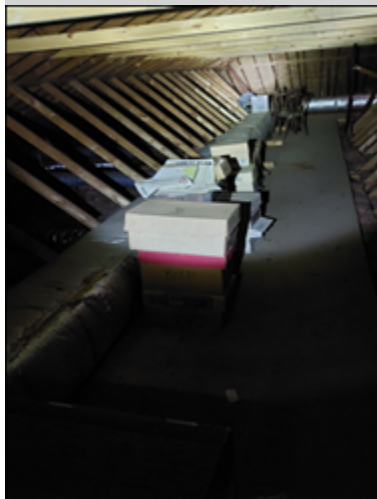
**(H5 - 1.4 ) Attic: Unfinished**

The attic is filled with boxes, furniture and other materials. Recommend having a General Contractor review and evaluate prior to remodel.

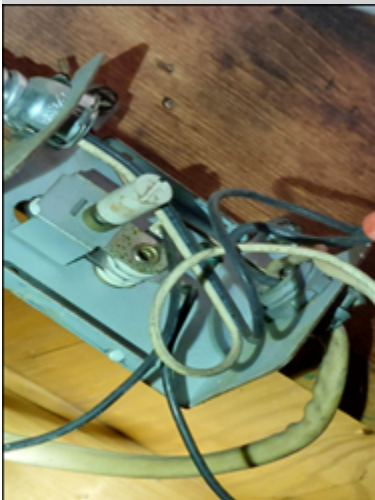
**(I1 - 1.3 ) Attic: All Accessible**

There is an open junction box located in the attic for fan control this a possible electrical shock hazard. Recommend a licensed electrical technician evaluate.
