# Property Inspection Report

**Report Number: NC22012**

1391 Plaza West Road  
Somewhere, North Carolina 12345

Date of Inspection: Tuesday, June 14, 2022

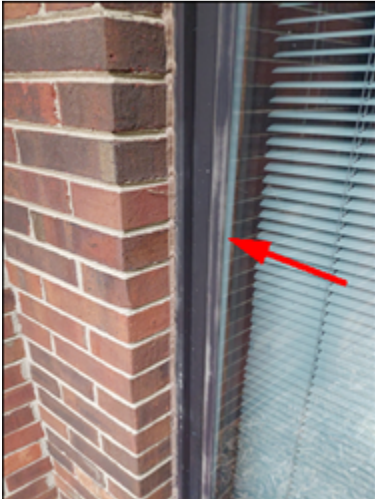
**(B2 - 1.2 ) Window**

All windows in building need to be caulked and sealed to avoid water penetration. Water penetration will lead to rot and mold. A licensed general contractor should be consulted to determine the extent of the damage and make necessary repairs.

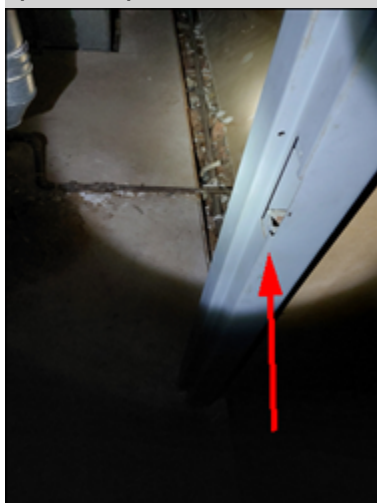
### (B2 - 1.6 ) Window

The fire doors in the attic that separate the gas furnaces DO NOT have strike plates. Therefore, the fire doors are not operating as intended. This is a safety fire hazard. A General Contractor should be consulted for further review.

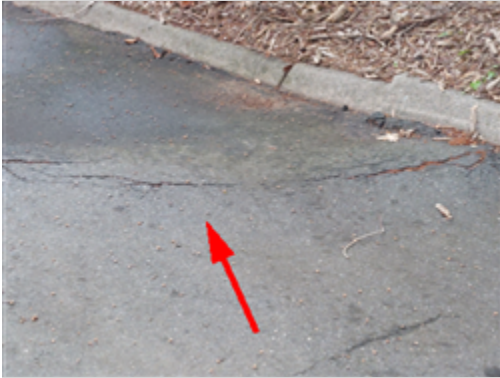
**(B4 - 1.2 ) Driveway**

The driveway is cracked and displaced. The raised section of the driveway has created a path for water penetration under the slab and a trip or fall hazard. A licensed general contractor should be consulted for further evaluation and repair.

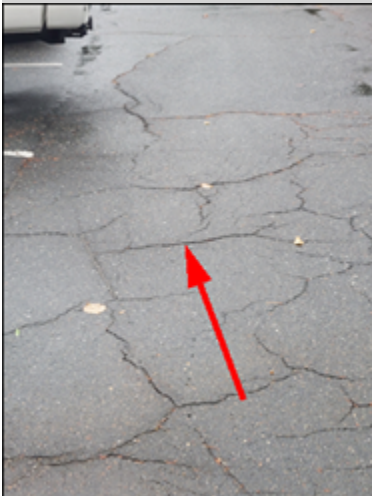
**(B4 - 1.5 ) Driveway**

The driveway is cracked and displaced. The raised section of the driveway has created a path for water penetration under the slab and a trip or fall hazard. A licensed general contractor should be consulted for further evaluation and repair.

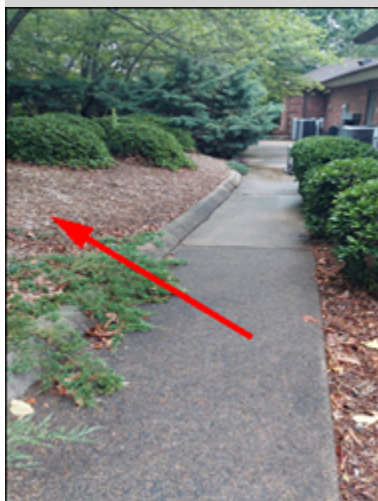
### (B5 - 1.2 ) Grading

The grading around the package HVAC unit is directing drainage toward the unit and into the building. Direct water penetration into the slab is undesirable and should be corrected. A licensed general contractor should be consulted to make necessary repair to ensure correct lot drainage and that the foundation area will be dry and stable.

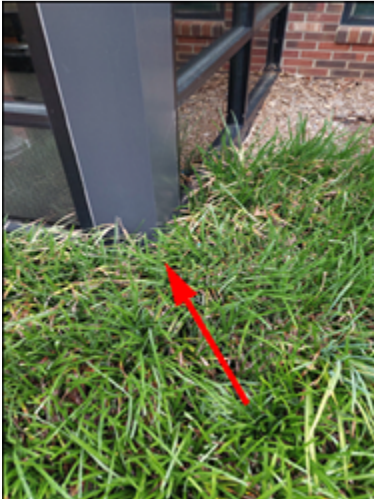
**(B5 - 2.2 ) Vegetation**

The vegetation around the perimeter of the building is over grown and blocks the air circulation around the building. The growth also limited the inspection access. A landscaping company should be consulted to correct the over growth and the inspection should be completed prior to purchase.

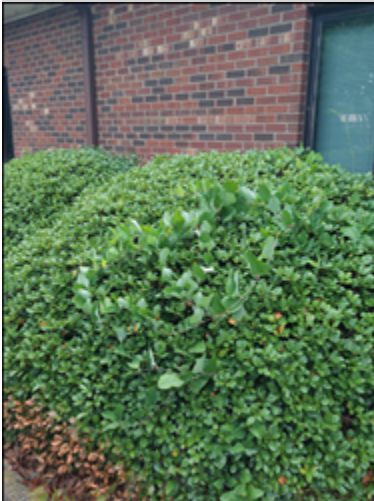
#### (B5 - 2.6 ) Vegetation

The vegetation around the perimeter of the building is over grown and blocks the air circulation around the building including the roof. The growth also limited the inspection access. A landscaping company should be consulted to correct the over growth and the inspection should be completed prior to purchase.

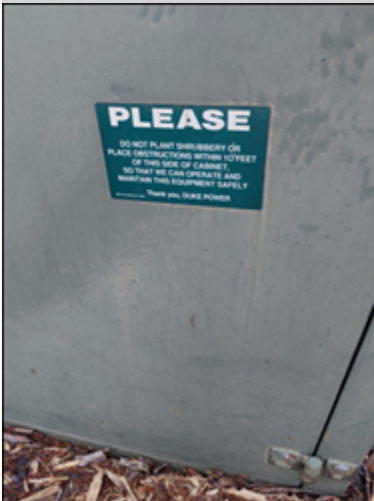
#### (B5 - 2.7 ) Vegetation

The vegetation around the transformer of the building is over grown and blocks the air circulation around the transformer. A landscaping company should be consulted to correct the over growth and the inspection should be completed prior to purchase.

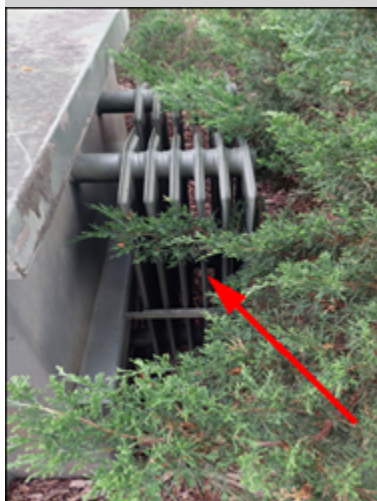
### (B5 - 2.8 ) Vegetation

The vegetation around the transformer of the building is over grown and blocks the air circulation around the transformer. A landscaping company should be consulted to correct the over growth and the inspection should be completed prior to purchase.

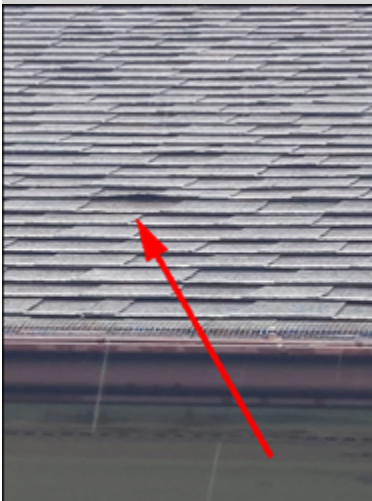
### **(C1 - 1.3 ) Main Building**

Exposed nails have displaced shingles over the roof surface. Displaced shingles could indicate an underlying problem with the shingles installation or attic conditions. A licensed roofing contractor should be consulted for a complete evaluation and to make necessary repairs to ensure the weathertightness of the roof covering system.

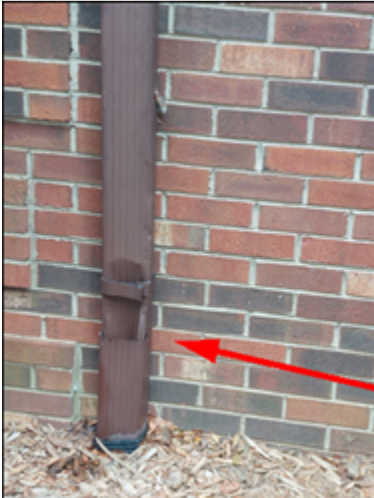
**(C2 - 1.3 ) Main Building**

There are several gutter downspout that are damaged and working improperly. Direct drainage to the foundation and cladding from the gutter system can result in water penetration into the foundation area and foundation deterioration. A licensed general contractor should be consulted for a complete evaluation and to make necessary repairs.

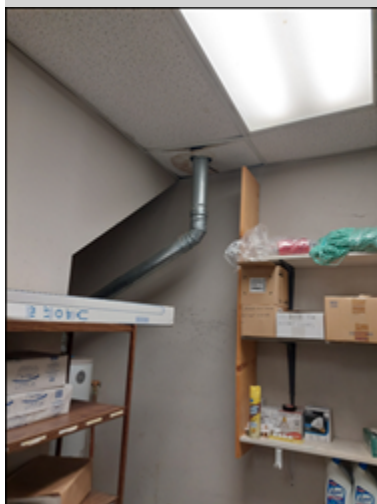
**(D3 - 1.1 ) Unit #1**

The water heating unit for this building is 9 years old. A water heating unit has a life expectancy of 10 to 12 years. The unit was noted to be operational and fair condition. The unit should be serviced annually and the TPRV inspected and or replaced every three years. The buyer should budget for replacement.

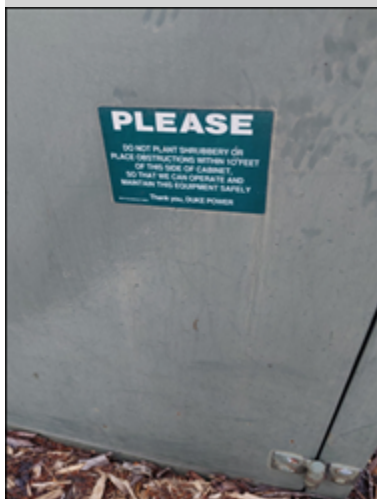
(E1 - 1.6 ) Underground

Transformer requires airflow around the exterior to keep it functioning as intended. According to label shrubs, trees etc. should be cleared 10 Ft around unit.

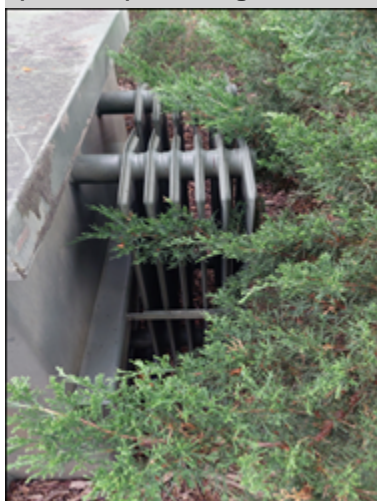
(E1 - 1.7 ) Underground

The service outlet at transformer is non functioning.

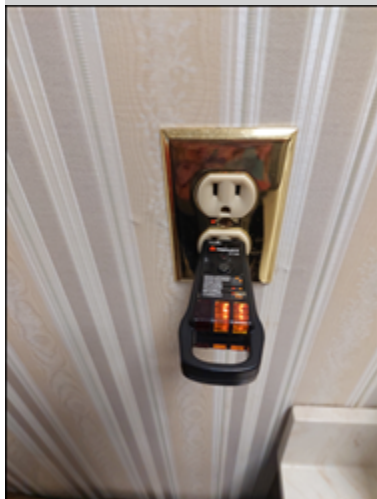
**(E5 - 1.2 ) Bathroom**

The building was built before GFCI circuits were required to protect all electrical receptacles located outside or within six feet of water. GFCI circuits add an important safety feature to electrical systems. The buyer should consider upgrading the electrical system to include GFCI protection.

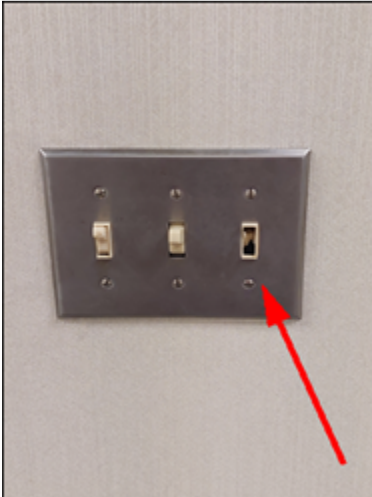
### (E5 - 2.3 ) Hallway

The receptacle(s) is/are broken in half leaving the top and bottom receptacle face loose. A broken receptacle could result in increased shock and fire hazards. A licensed electrical contractor should be consulted to make necessary repairs to ensure safe and proper operation and installation.
